River Dyke Reconstruction Lower Kootenay Indian Band

River Dyke Reconstruction

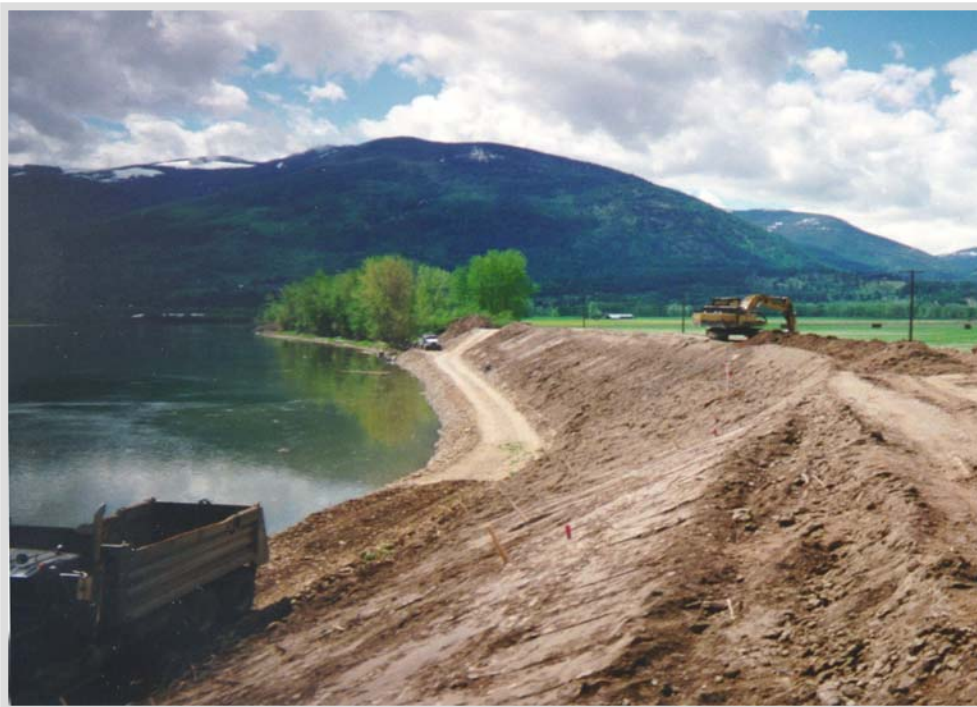
River erosion had removed nearly 50% of the width of the dyke on a bend in the Kootenay River near Creston. Approximately 175 m of dyke reconstruction was required including resloping the front side of the dyke to 2:1. Following the shaping of the dyke a 0.5m thick layer of well-graded gravel was placed on the riverside slope of the dyke. This material acts as both erosion protection and a filter to retain the fine grained silty material of the dyke core.
